TECHNICAL REPORT REMR-CO-3

CASE HISTORIES OF CORPS BREAKWATER
AND JETTY STRUCTURES

Report 2

SOUTH ATLANTIC DIVISION

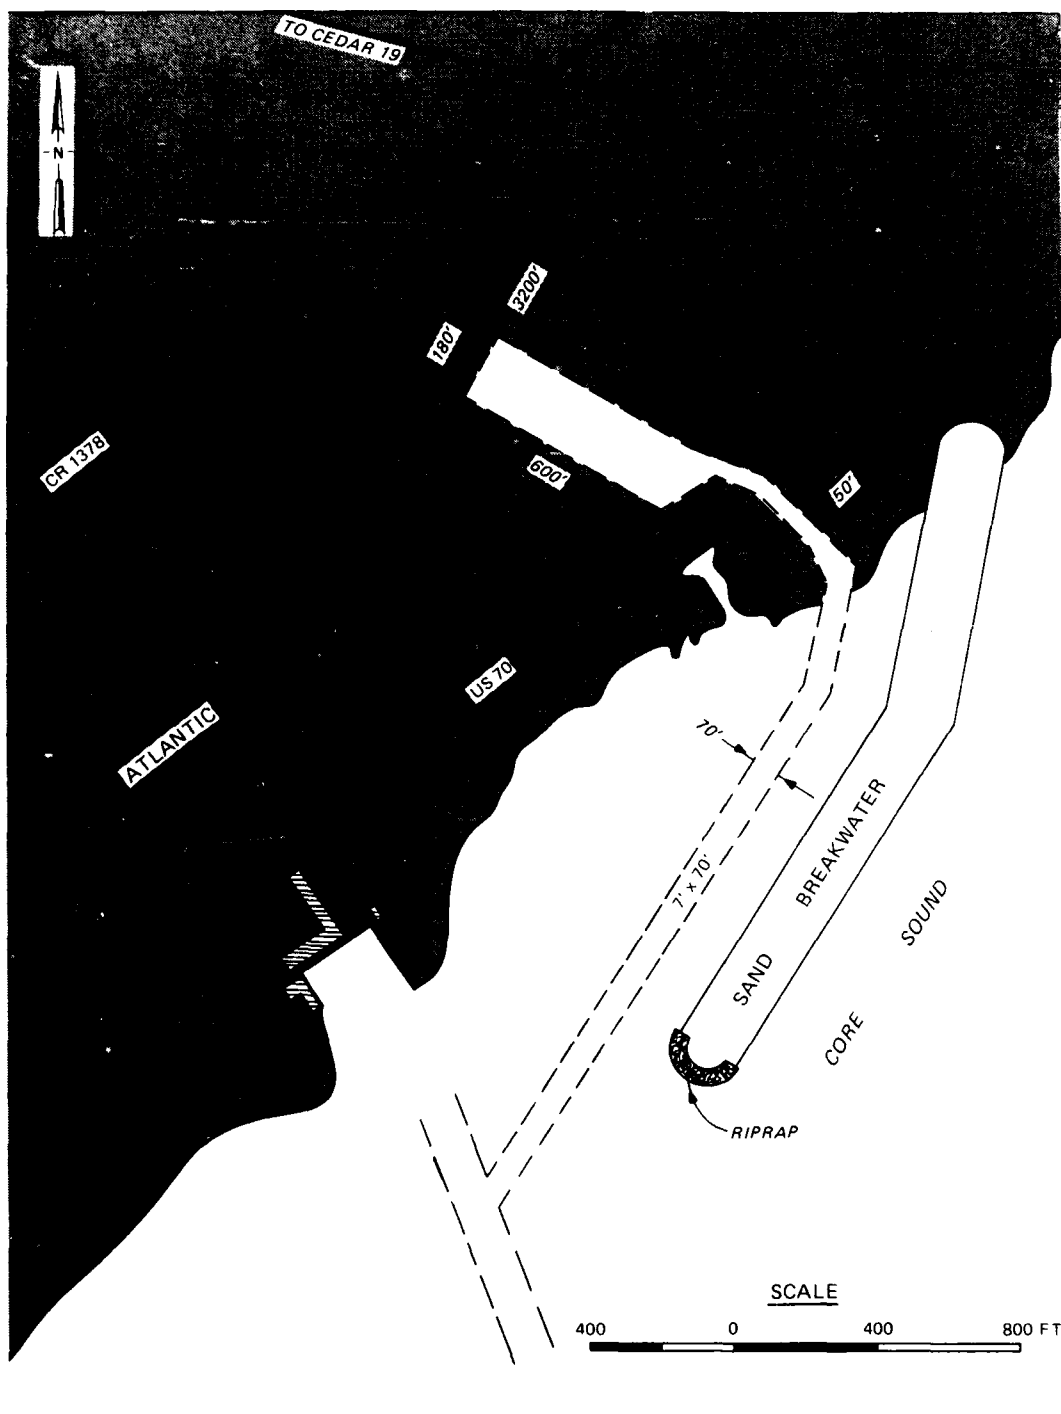
Figure 8. Atlantic Harbor of Refuge, North Carolina

Date(s)	Construction and Rehabilitation History
1971- 1972	A 2,000-ft-long sand breakwater (Figure 8) with a riprap head was constructed in February 1972 as part of the Harbor of Refuge project. Material dredged from the access channel was used for the breakwater. A tentative design section called for a crest width of 15 ft at an elevation of +8 ft mlw, with side slopes of 1V:10H above mlw and 1V:20H below. The head of the breakwater would have a 3-ft-thick riprap section from -1 to +3 ft mlw. This design section was similar to the one used on the Stumpy Point Bay breakwaters. Estimated quantities were 46,500 cu yd of sand, 3,232 tons of stone, and 6.5 acres of grass (to hold the sand in place). The estimated total cost was \$51,400.
1973	Erosion had occurred along a 400-ft section of the southeastern face of the breakwater. The erosion extended from 35 to 60 ft into the embankment, creating an escarpment of about 3 ft, and the planted grass had been destroyed in this area. Also, the stone protection on the south end of the breakwater (previously covered with sand) had become uncovered, displaced, and scattered. The sand fill behind the stone apparently eroded away first, undermining the rock and subsequently displacing it.

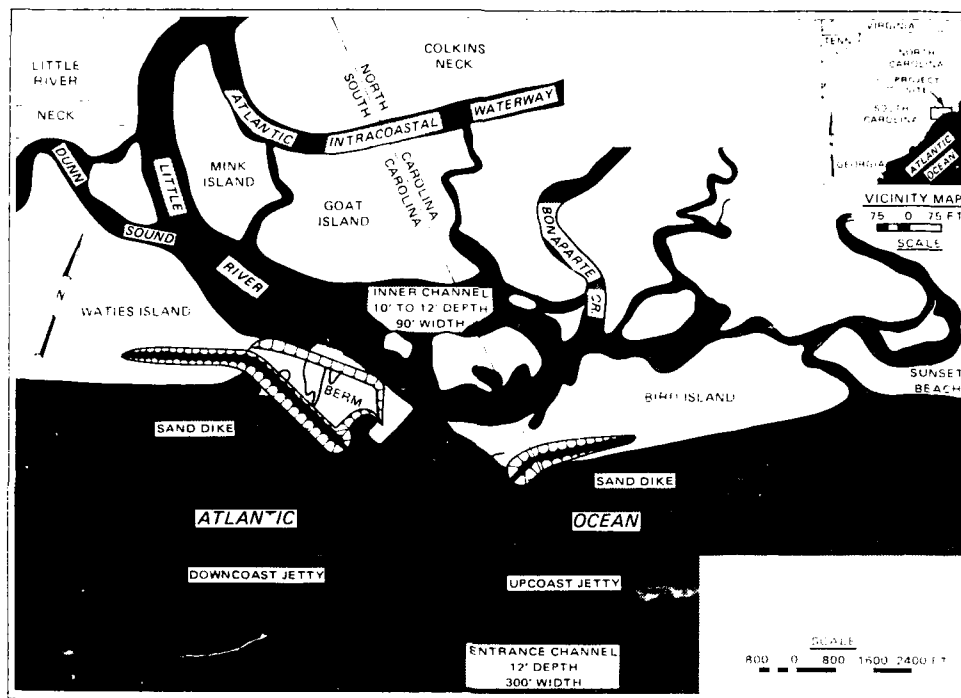
Figure 14. Little River, South Carolina

1986	<p>A visual examination of the structures indicated some displaced stone along the weir section of the north jetty. Surveys also revealed scour holes at the head of the north jetty and along the channel side of the south jetty. No apparent jetty damage was indicated above the water surface. Damage along the toe of the structures, if any, is unknown.</p>

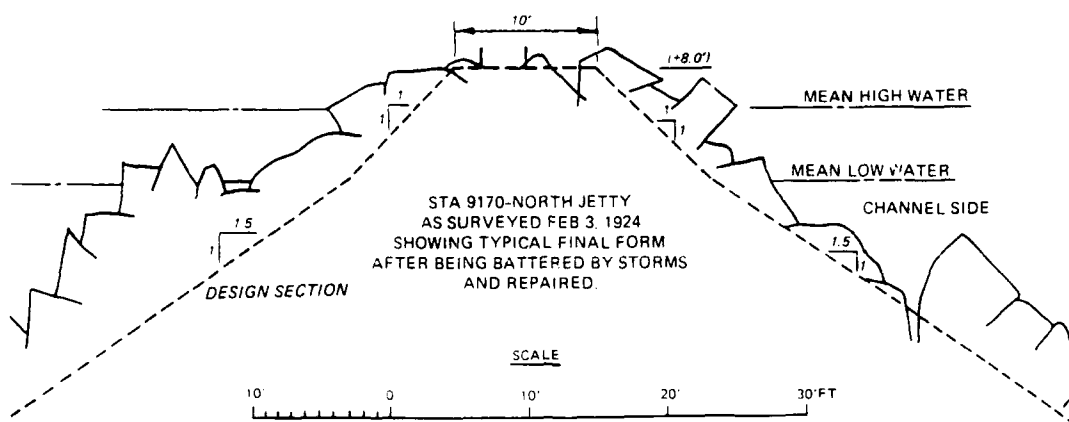
b. North jetty, 1923

1897- 1928	<p>During this period both jetties were raised above mhw (+4.9 ft), numerous repairs were made to the jetties, the north jetty was extended seaward 2,070 ft, and the channel depth was increased to -30 ft mlw. The method of jetty construction by this time was to place the stone directly on the natural bottom with the smaller stone placed at the bottom and the larger stone placed above mlw. The size of the largest armor stone used increased during this time from a typical size of 4 to 7 tons. Figure 23b shows a cross section of the north jetty taken shortly after work was completed during 1923. This design section consisted of a 10-ft-wide crest at</p>

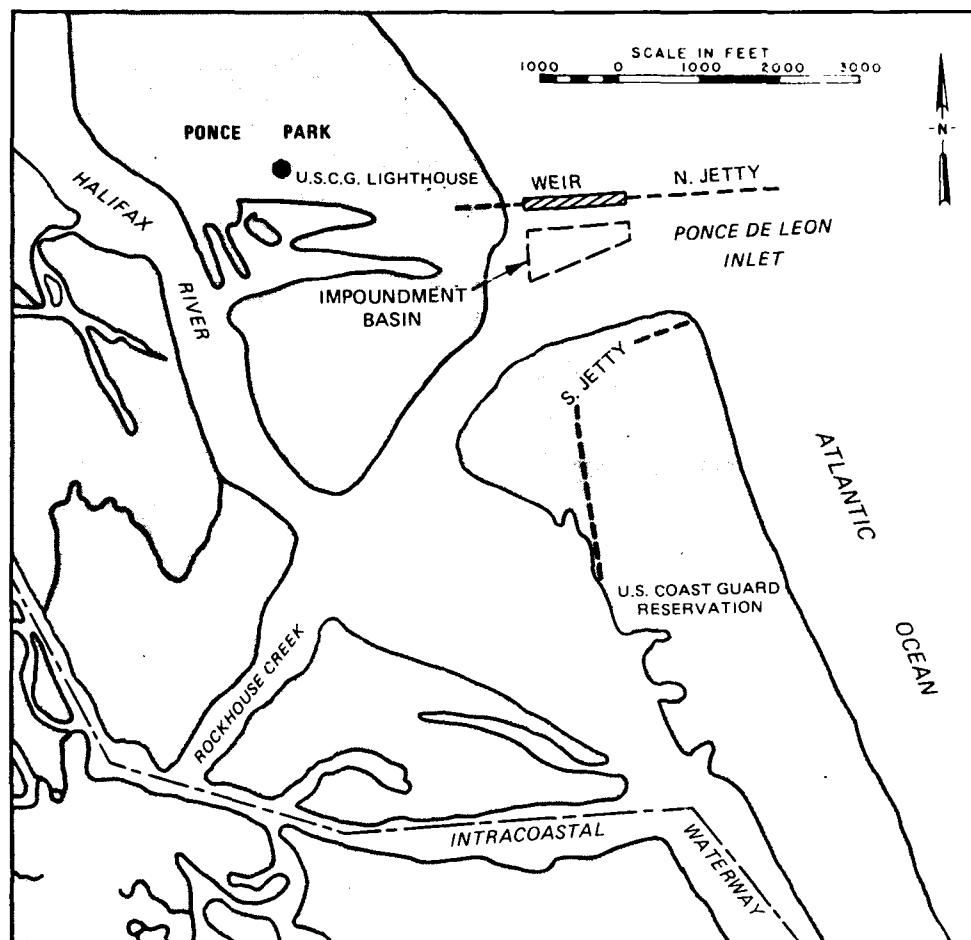
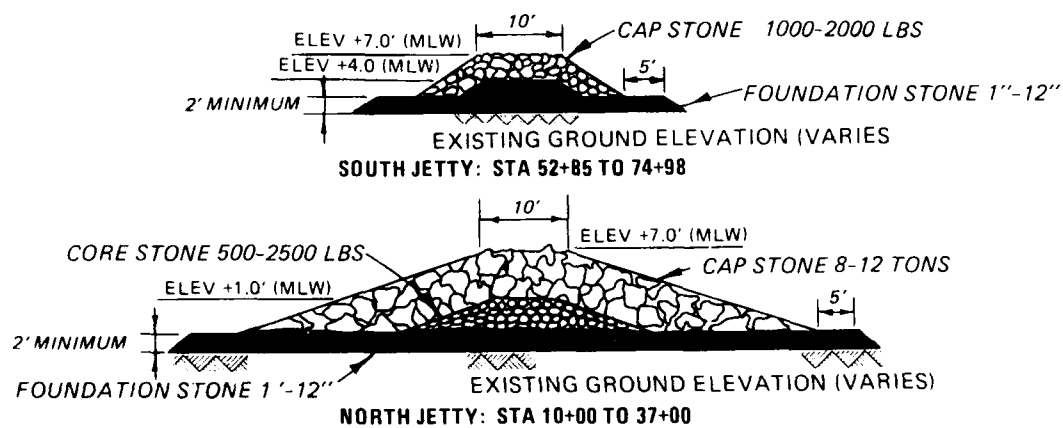
Figure 29. Ponce de Leon Inlet, Florida

Date(s)	Construction and Rehabilitation History
1981	Erosion at the root of the north jetty required placing stone over a 375-ft section of the existing jetty beginning 125 ft from landward end. The repair cross section consisted of a 1.5-ft layer of 1- to 50-lb bedding stone, a core of 30- to 1,000-lb stone, and 0.5- to 2-ton capstone. Side slopes were 1V:2H with a 5-ft crest width and crest elevations varying from +9 to +12 ft mlw. Additionally, 1,150 tons of bedding stone, 1,970 tons of capstone, and rearrangement of stockpiled core stone were used in the repair.
1982- 1983	The north jetty weir section was closed using core and armor stone (no details). Armor stone size and cross-section geometry were similar to those for the existing rubble-mound section at the seaward end of the weir section.
1985	The jetties are presently in good condition except for some damage on the north jetty head because of a recent storm and continued erosion at the root of the jetty.

1978	<p>A blanket of armor stone was placed at the base of the north jetty along the seaward 2,550 ft. A total of 23,100 tons of up to 700-lb riprap stone and 9,100 tons of 500-lb to 3-ton stone (75 percent greater than 1 ton) was placed. The cost of the repair was \$1,453,000.</p>

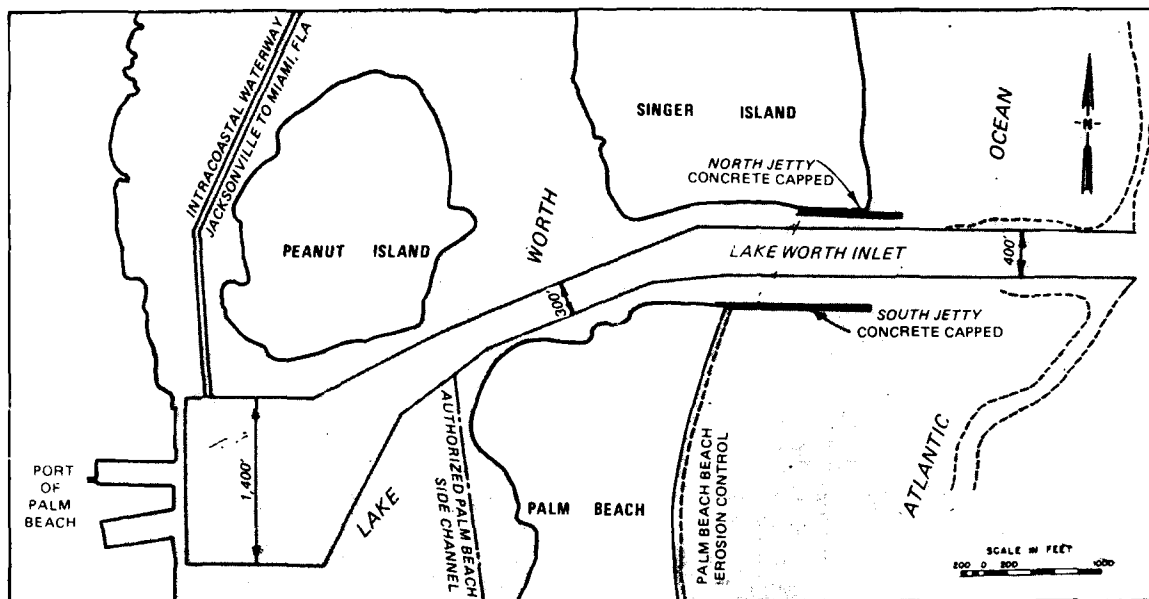
Figure 33. Palm Beach Harbor, Florida

1945	A 40-ft section of the concrete cap on the south jetty approximately 420 ft from the shoreward end had settled about 4 in., had longitudinal cracks, and was acting as a beam. These occurrences were brought on by tidal scour through, and settlement of, the underlying armor stone. The cause of the problem was thought to result from the lack of additional armor stone placed in this and adjacent sections of the old jetty during the 1934-38 rehabilitation. The north jetty was in good condition, and its only problem was its ineffectiveness as a barrier to tidally-induced sand motion under the structure. This problem was evidenced in the original jetties and

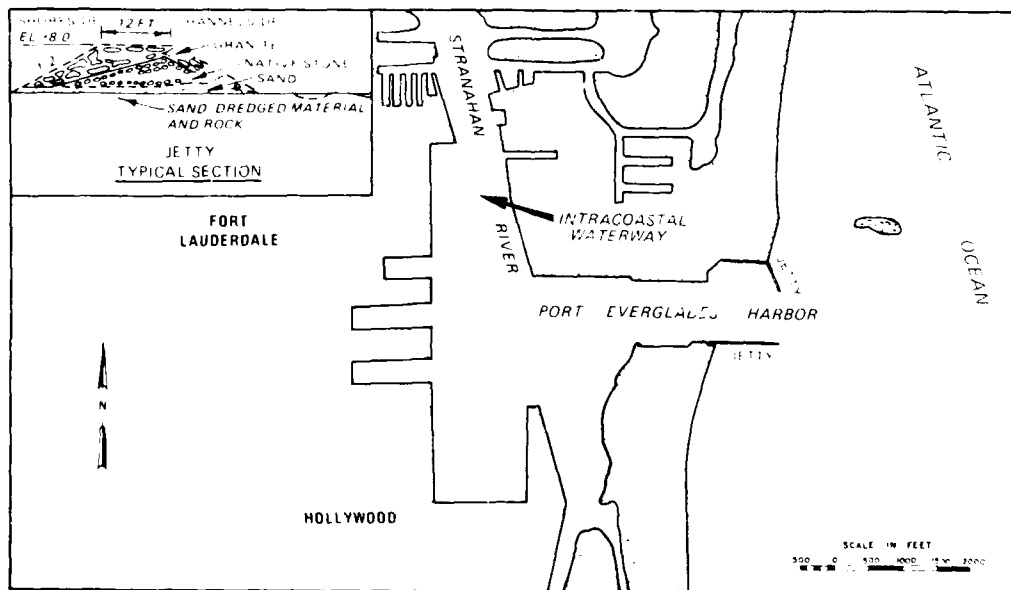
Figure 35. Port Everglades Harbor, Hollywood, Florida

1984- 1985	The inner ends of the jetties were repaired by rebuilding the armor stone layer with new and existing stone. To allow the jetties to be used as fishing piers, void spaces were chinked with smaller stone, and a layer of asphalt was piled on the crown. Prior to the repairs, the inner ends were in very poor condition with numerous void spaces while the remaining parts of the jetties were considered to be in satisfactory condition.

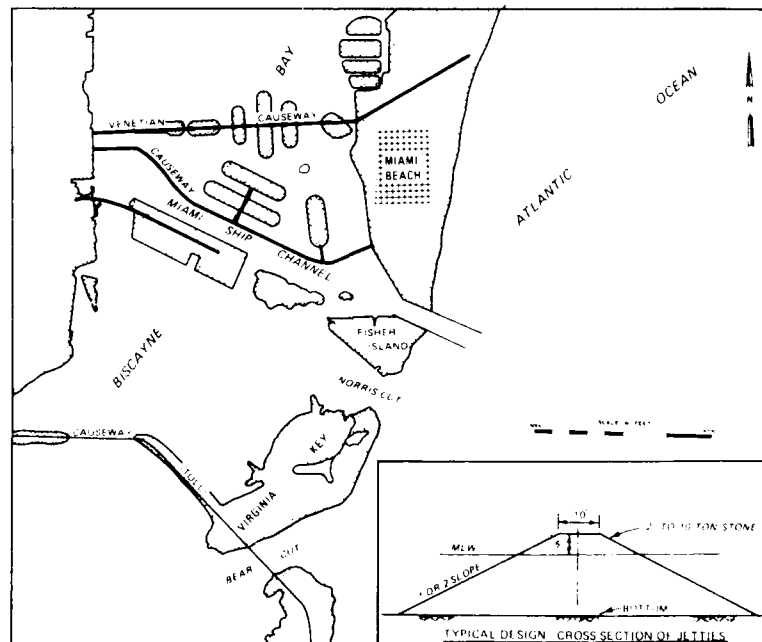
Figure 37. Miami Harbor, Florida

1985	Presently a 38-ft-deep by 400-ft-wide channel is maintained between the jetties. Except for the sand-tightened portion (1983), the jetties have not been repaired since 1934 and, although in poor condition, are still functioning properly.

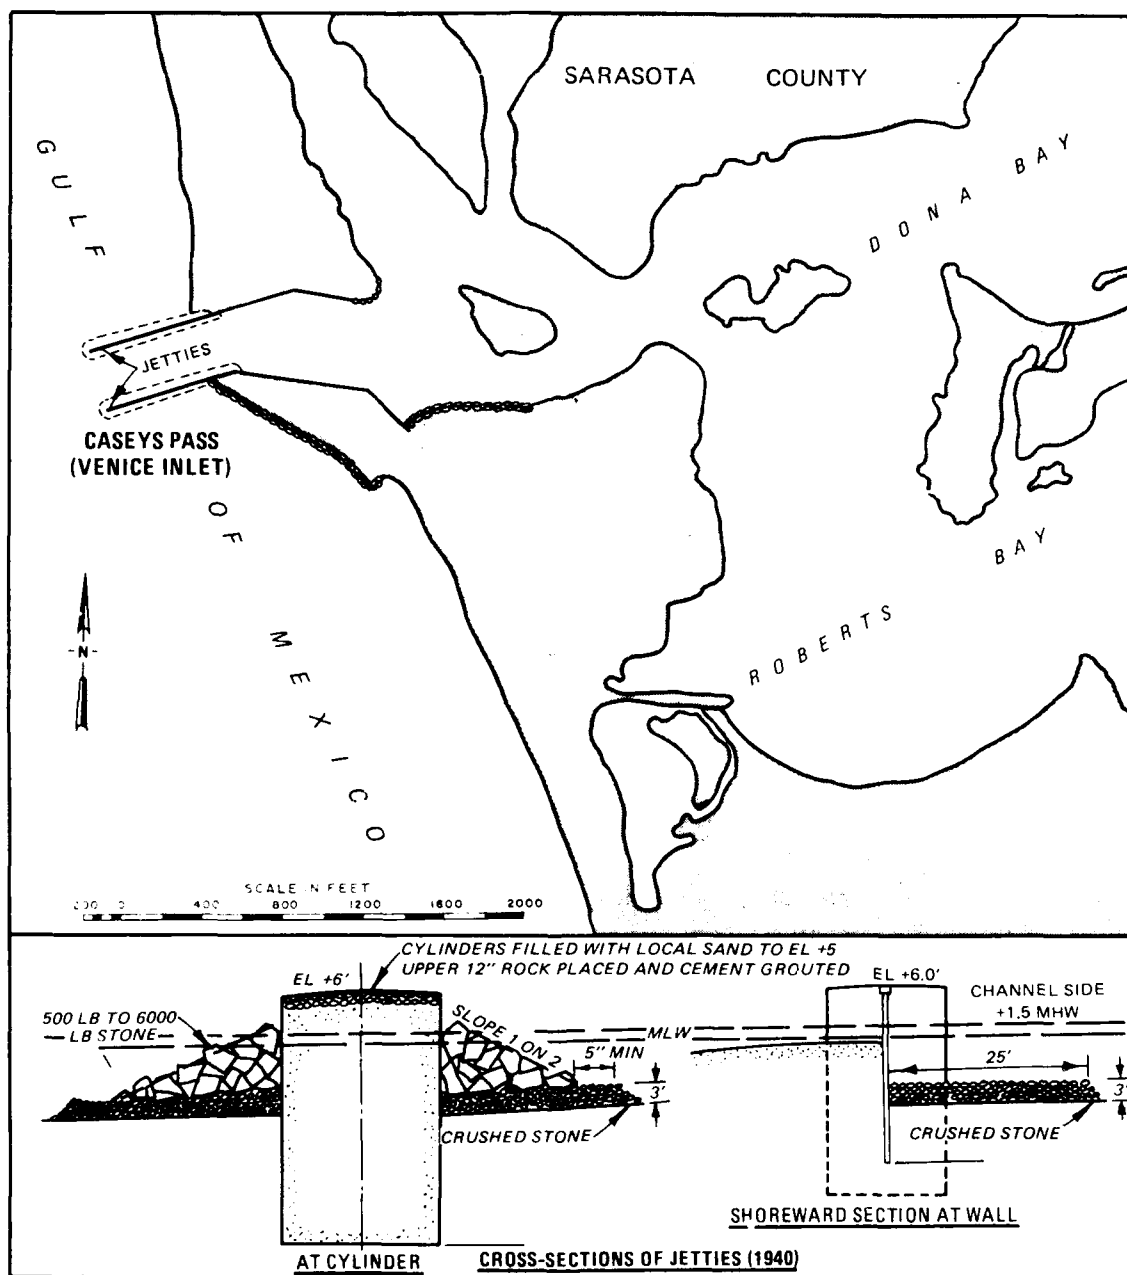
Figure 39. Casey's Pass, Florida

1950- 1951	Jetty surveys showed that the heads and seaward sides of the jetties needed repairs. The channel side of the north jetty needed repair because of the proximity of the channel causing scouring at the toe.
1955	Repairs were made to the seaward end of the south jetty which was in a "severely damaged" condition. A total of 650 tons of 3- to 6-ton cover stone was placed on a 2-ft-thick foundation blanket of 2- to 6-in. stone at a total cost of \$6,500. Repairs were also made to the collapsed concrete caps on the 1st and 8th caisson from its seaward end. Nearly 3/4 of the first caisson was severely damaged, and 3- to 6-ton cover stone was placed to +6 ft mlw with a 10-ft crown width. The upper 4 ft of the 8th caisson was filled with stone, and the upper foot of this was capped with concrete grout.
1963	Repairs to the concrete cylinder caps and jetty stone/rock revetments were made at a cost of \$30,000. At this time, the channel was dredged to a depth of -9 ft mlw. Along the exposed seaward sections, 3- to 6-ton capstone totaling 615 and 770 tons was placed on the north and south jetties, respectively, and approximately 20 capstones were reset. Several of the seaward cylinders were repaired. Their caps and sand were removed to -1 ft mlw, replaced with the broken pieces of the cap and 20- to 200-lb stone, and grouted with concrete throughout the upper 18 in. of stone.

Date(s)	Construction and Rehabilitation History
1968- 1969	<p>Visual examinations and detailed surveys showed the sheet-pile cylinders and walls to be in need of immediate repairs. Voids between the original concrete caps and the underlying sand existed in virtually all cylinders not repaired in 1963. Corrosion was the main cause of deterioration, with subsequent removal of sand from the cylinders because of wave and current action. Rehabilitation of the jetties was carried out in 1969 (Figure 40). The sheet-pile walls and cylinders (except the outer two on the north and outer one on the south) were removed down to +2 ft mlw, and the sand within the cylinders were removed to mlw. The existing concrete cap (broken into pieces less than 12 in. long) and 1- to 12-in. bedding stone were placed in the cylinders to +2 ft mlw. This was overlaid with 4- to 10-ton capstone (70 percent > 8 tons), with similar capstone placed along the connecting walls, to bring the structure to the original design elevation of +6 ft mlw with a crown width of 10 ft. Additional 4- to 10-ton capstone was placed, as needed, to bring the side slopes up to 1V:2H. On the outer 50 ft of the jetties, the side slopes were 1V:3H. Finally, asphaltic concrete was placed (Figure 40) on the jetties. This material was placed over the entire crown width down to mlw, and had 1V:1H side slopes. The design of the jetties used Hudson's formula with wave heights of 12 to 16 ft and wave periods of 7 to 9 sec.</p>

1978	<p>Repair to jetties consisted of resetting stone and adding 6- to 12-ton stone (75 percent > 10 ton) on the outer 200 ft of the jetties and 2- to 6-ton stone on the next 450 ft of the jetties as needed to solidify the structure.</p>
1985	<p>The jetties are in good condition except for their head sections which are in need of some repair.</p>

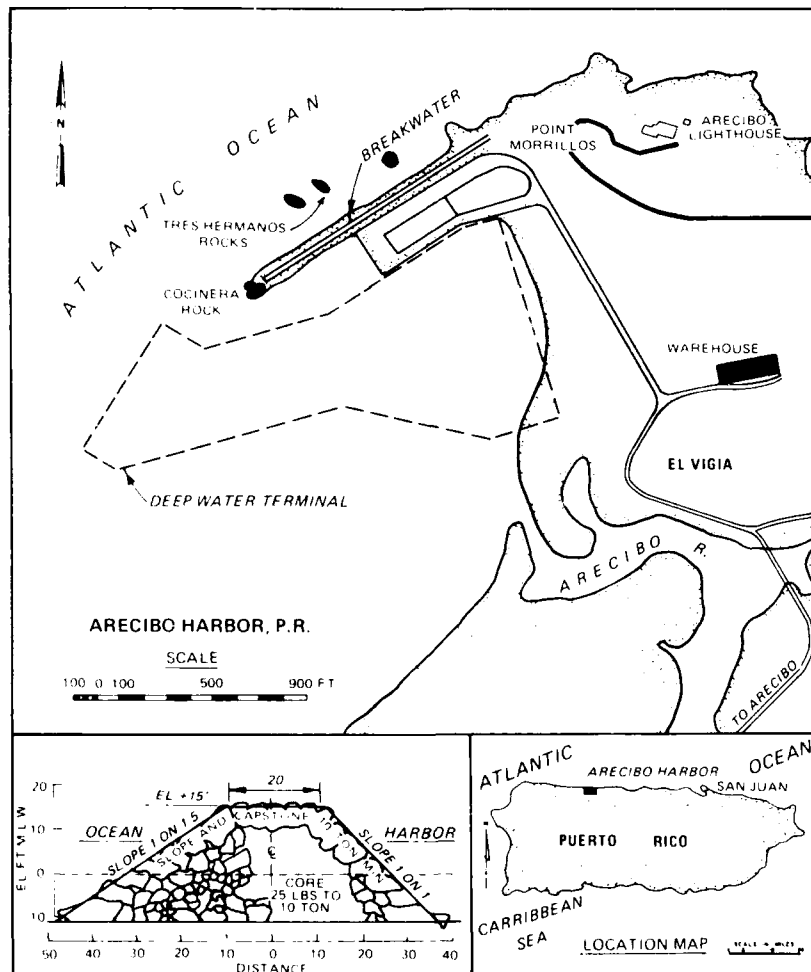
Figure 41. Arecibo Harbor, Puerto Rico

Date(s)	Construction and Rehabilitation History
1944	A 1,200-ft armor stone breakwater was completed, providing protection for the harbor and its 25-ft-deep access channel (Figure 41). The breakwater cross section (Figure 41, inset) was comprised of 25-lb to 10-ton core stone protected with one layer of armor stone, 10-ton minimum weight. A recent (1983) visual examination indicated that most of the armor units were 10 to 18 tons). The side slopes were 1V:1.5H on the ocean side and 1V:1H on the harbor side. The crest width and elevation were 20 ft and +15 ft mlw, respectively. The breakwater was constructed along a reef with a depth varying from -20 ft mlw at its seaward end to mlw at its landward end.
1951- 1952	Repair work consisted of resetting armor stone and placing about 8,300 tons of new granite stone at an estimated cost of \$66,400. The structure was rebuilt to its original design geometry and stone sizes, except for the outer 50 ft which was not repaired. Damage resulted from wave action which caused dislodgement of stone and settlement of portions of the breakwater. A subsequent Chief of Engineers report indicated that the armor stone along the slope of the structure showed signs of "sliding."

1983	A field inspection and a condition survey were made to identify damaged areas for rehabilitation purposes. The general damage (Figure 42) was above mlw, and the ocean-side slope of the submerged part of the structure had increased to 1V:2H or greater. In particular, about 160 ft of the seaward end had subsided to approximately mlw. Several areas on the trunk section had unprotected core stone on either side of the structure.
1984	Rehabilitation of the breakwater consisted of rebuilding the outer end of the breakwater and restoring damaged sections by placing about 42,000 tons of armor stone, ranging in size from 11 to 29 tons (Figure 42). A double layer of armor stones was provided on the seaward side of the structure along a reach beginning about 350 ft from the shore end of the breakwater and extended toward the outer end, a distance of 450 ft. A double layer of armor stone was placed on both sides of the structure for the next 265 ft. The remaining 155 ft, at the seaward end of the structure, was rebuilt to +15 ft mlw, as were the other sections. The crest of the damaged sections was restored to a width of about 26 ft for the first 800-ft reach. The crest of the outer 420-ft section was widened to about 36 ft, flaring out to about 50 ft at the extreme outer end. Armor stone slopes for the ocean and harbor sides were 1V:2.3H and 1V:1.5H, respectively. Based on utilizing local stone, the cost of the work was estimated to be \$3,900,000. The design analysis used was the

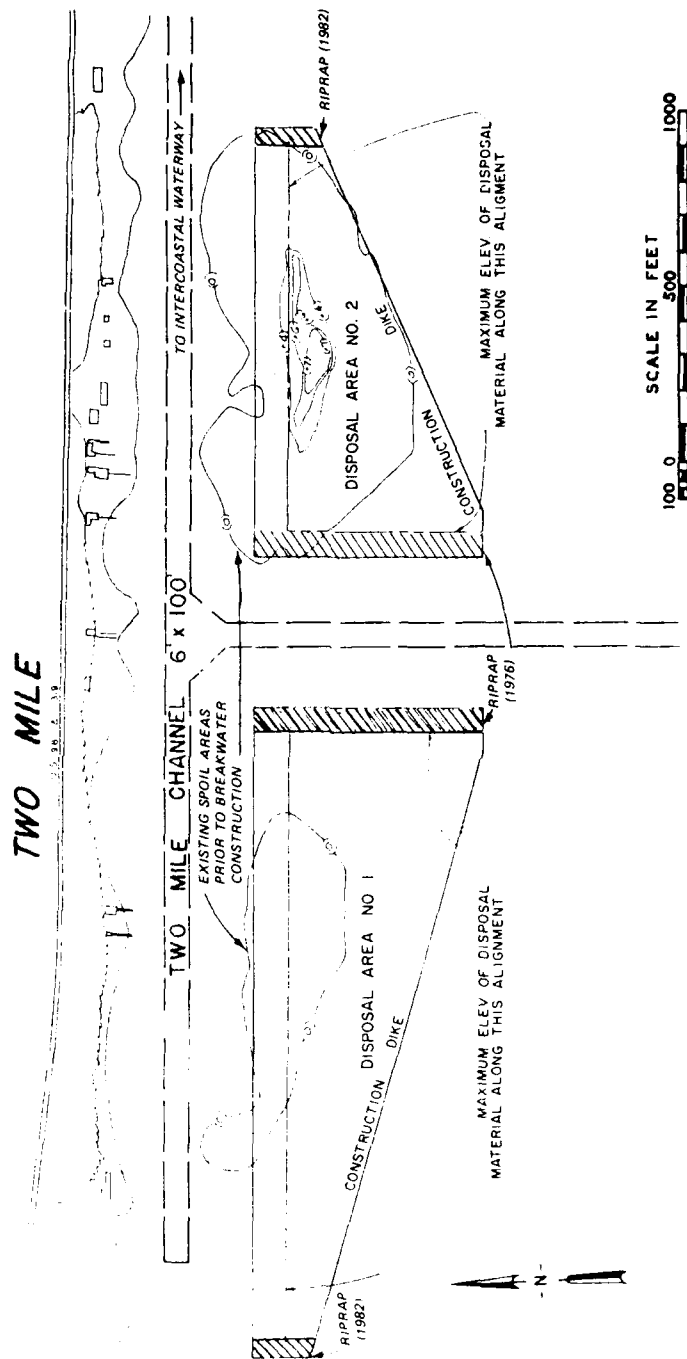
Figure 45. Two Mile breakwaters, Florida

1982	<p>The outer ends of the two breakwaters had been eroding and were revetted with stone left over from the original construction.</p>
1985	<p>The breakwaters are presently in good condition.</p>

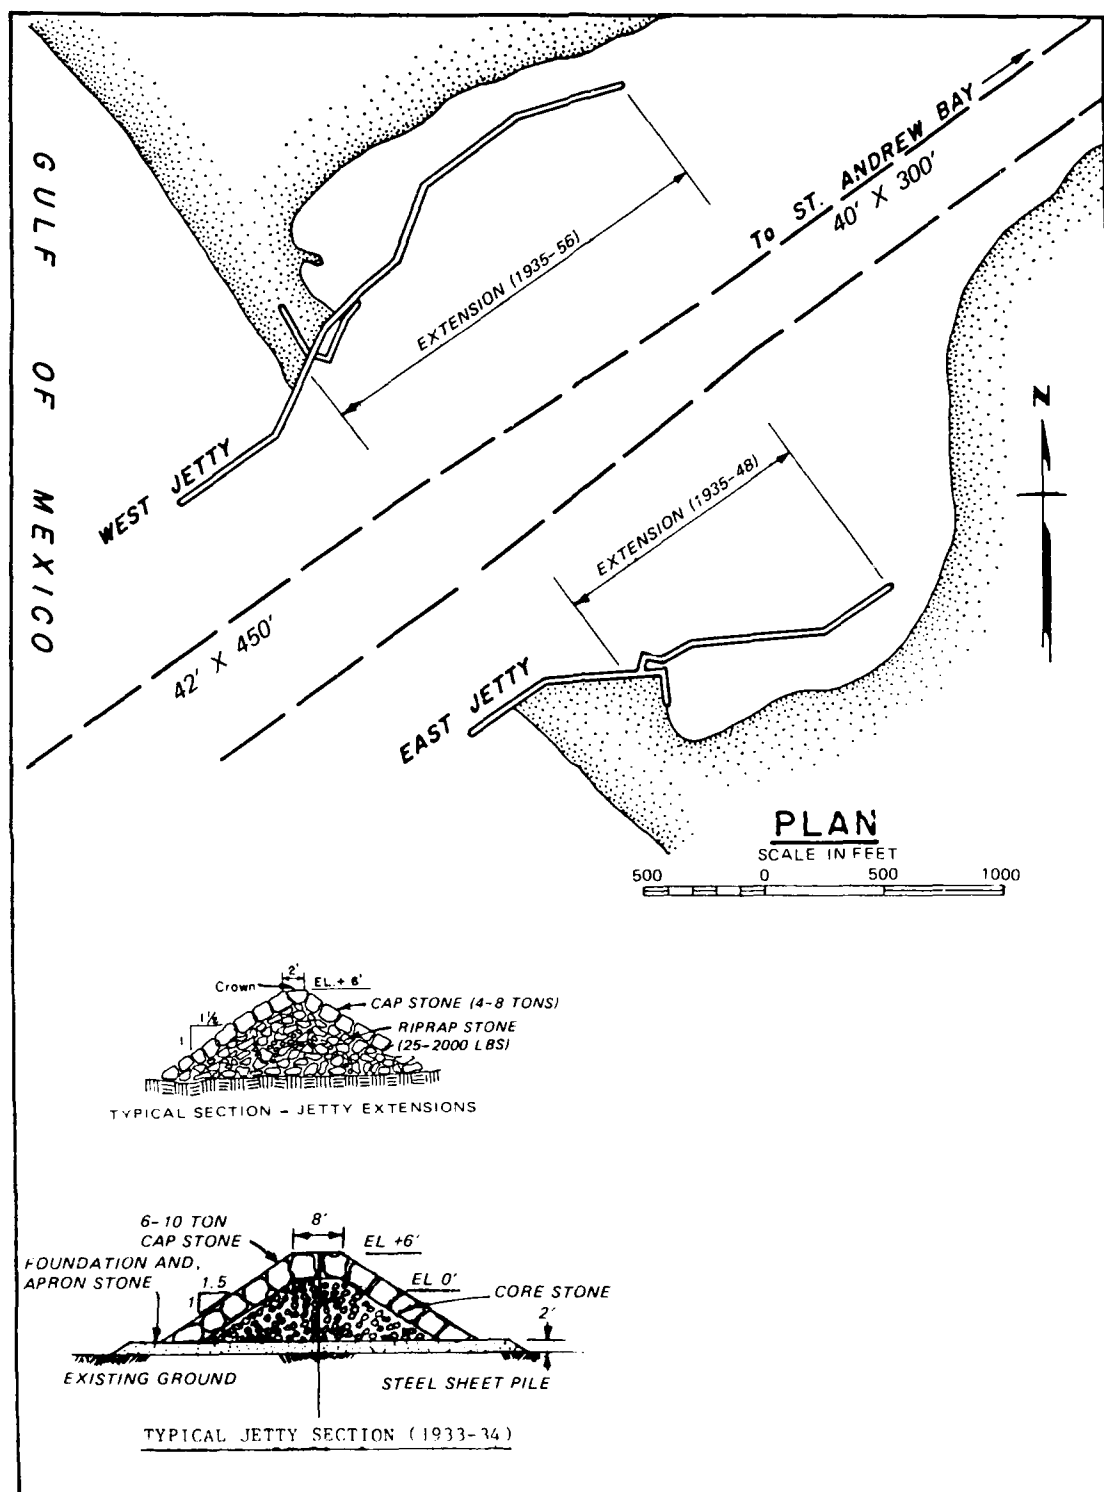
Figure 48. Panama City Harbor jetties

Date(s)	Construction and Rehabilitation History
1936 (Cont)	827 tons of rock and 96 cu yd of concrete were placed to repair breaches in jetties. The efforts to reinforce the sheet pile with riprap failed, and erosion shoreward of the jetty wings continued, making further shoreward extensions of the jetties necessary. The cost of repairs, as of 1 July, was \$74,600 (FY 35). The 31 July hurricane severely damaged the jetties. The average crest elevation of the jetty wings was +1 ft mlw, and considerable erosion occurred, especially along the west jetty wing.
1937- 1938	Sheet pile (259 lin ft) was placed along the shore near the west jetty wing, and 7,600 sq ft of sheet pile was salvaged from damaged bulkheads. Including preparations for jetty repairs and maintenance dredging, the total cost, through 30 June 1937 (FY 36), was \$159,300. Repairs to jetties (including the wings) were made with hot asphaltic concrete and precast reinforced asphaltic concrete mats. The 2-in.-thick asphaltic mats extended 24 ft from the toe of the jetties and were anchored at the toe with precast asphaltic concrete blocks. The mats were consolidated with the existing jetty section by placing hot asphaltic concrete to form an impermeable section with a top width of 8 ft and elevation of +6 ft mlw. The east and west jetty wings were extended 210 and 270 ft, respectively. These extensions were made by grading sand slopes and covering with 2 layers of asphaltic mat. Steel sheet-pile retaining walls (10,300 sq ft) were placed along the inner ends of the jetties. Asphaltic mats (167,000 sq ft) and 25,870 tons of asphaltic hot mix and blocks were placed on various sections of the jetties. The cost of the jetty repairs plus maintenance dredging through 30 June 1938 (FY 37) was \$469,700.

1939- 1941	In 1939 the east and west jetty wings were extended 110 and 400 ft, respectively. These extensions and additional repairs were carried out by placing 1,465 and 1,540 tons of stone on the east and west wings, respectively. A 200-ft-long west jetty cross wall was constructed by placing 205 tons of stone. Although no details were available, the 100-ft-long east jetty cross wall was probably constructed about this time. An additional 820 and 2,370 tons of riprap and cover stone were placed on the west jetty during 1940-41 repair work. A total of 11,200 sq ft of steel sheet pile was salvaged as part of the jetty repair work. The cost of the 1939 jetty repairs and maintenance dredging was \$50,400 and of the 1940-1941 jetty repairs was \$35,900.
1942	The east jetty wing was extended 570 ft using 1,380 and 3,160 tons of riprap and cover stone, respectively. The west jetty wing was extended 400 ft using 640 and 2,030 tons of riprap and cover stone, respectively. The design cross section (Figure 48, inset) had a

1948	Repair work and landward extensions of 300 and 360 ft on the east and west jetty wings, respectively, were made at a total cost of \$143,000. The design cross section was identical to that of the 1942 extension. Also, Congress authorized a 34-ft-deep (5 ft deeper) by 450-ft-wide channel between the jetties (this depth was being maintained as early as 1956).
1951	Repairs were made to the jetties with 1,980 tons of stone placed at a cost of \$22,000.
1956	The west jetty extended approximately 600 ft on its landward end with 410 and 7,330 tons of riprap and cover stone, respectively, at a total cost of \$76,300. At this time the cumulative lengths of the east and west jetties were approximately 2,000 and 2,750 ft, respectively.
1957- 1959	Minor repairs consisted of placing 631 tons of stone, and 960 tons of stone were stockpiled. Total cost was \$11,300.
1961- 1962	Repairs were made by placing 7,270 and 13,500 tons of stone along the landward sides of the east and west jetty wings, respectively. The repair section (Figure 49) was to have a crest elevation of +6 ft mlw, a crest width of 4 to 10 ft, and a 1-V:1.5-H side slope. Capstone of 8- to 10-ton size was placed on the inner 1,235 ft of the west jetty, and 6- to 8-ton capstone was placed along an adjacent 430-ft section and on the inner 1,025-ft of the east jetty. The design was based on Hudson's equation and 10- to 12-ft wave heights. A 2-ft foundation blanket of 15- to 200-lb stone was placed and overlaid on the capstone and 100- to 1,000-lb core stone.
